UPR-NF Provides Performance at the Extreme

Polywater® UPR™ Saves Customer Time and Money with Remote Pole Repairs

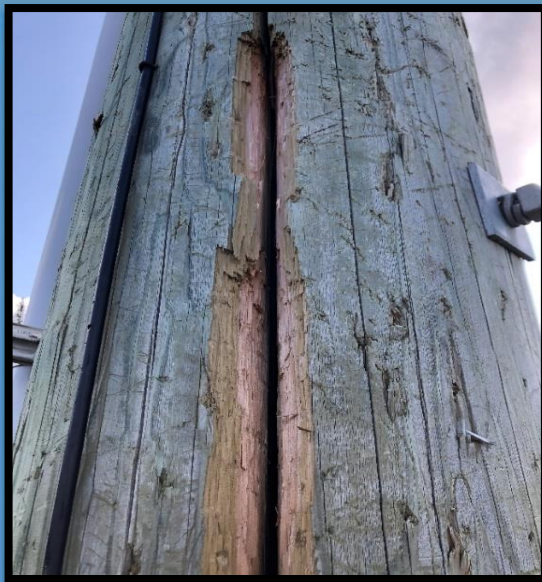
A large oil and gas facility in northern Alberta had more than 60 severely cracked wooden utility poles that were further damaged by woodpecker foraging. The poles either needed to be replaced or repaired to limit further damage and loss of mechanical integrity. Due to their remote location, the logistical costs of moving new poles to the site were too high to justify replacement. The maintenance crew decided to repair the existing wooden utility poles. The company needed a product that could fill the voids and halt the damage from pests and moisture. So, they reached out to Polywater to inquire about a product solution that could fill the cracks while preventing further damage to their utility poles.

Close up of cracks

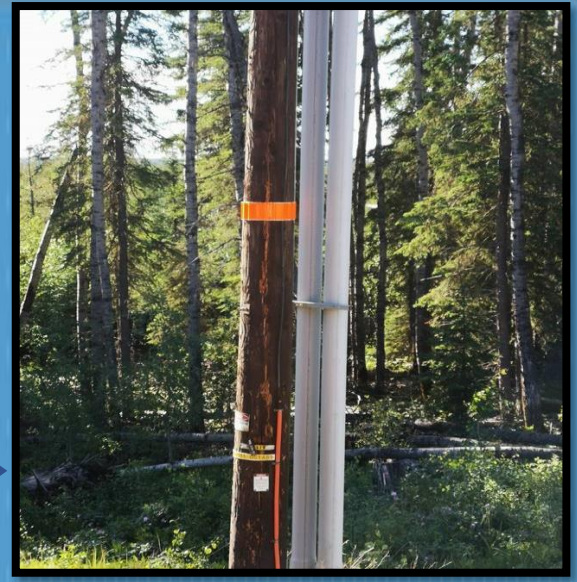
Full view of repaired pole

Long, deep splits in the 60-foot poles required a repair product that could stay in place in the voids to protect the interior of the poles over the long term. After testing at Polywater's lab and in the field, Polywater recommended its Utility Pole Repair (UPR-NF) "No Flow" Utility Pole Repair product for the application. UPR-NF is formulated to thicken immediately to reduce product waste through cracks, voids, and large cavities. The heat generated during UPR's curing phase is high enough to kill many of the microbes responsible for potential wood rot in poles. Using UPR-NF also prevents further physical deterioration to the interior of the Class 1 poles, reducing the risk of mechanical failure. Filling voids, prevention of rot and, improved mechanical integrity all contribute to extend the physical and economic lifetime of damaged utility poles.

COST DATA (\$CAD)	DATA	NOTES
Total Costs:	Replace: ~\$452,880 vs. Repair: \$45,480	Product + Transportation
Pole Replacement Cost: (Class 1, 60')	~\$6804/pole	Pole cost, non-delivered
Transportation costs:	Poles: ~\$44,640 vs. UPR Kits: \$0	UPR freight paid by suppliers
Repair Cost:	~\$758/pole	Avg. per pole
SITE DATA		
Pole diameter(s):	10" – 24" (25 cm – 61 cm)	Class 1
Damage information:		
Crack Heights	1' – 8' (61 cm – 244 cm)	9 – 10 cartridges/deep cracks
Crack Widths	2" – 4" (5 cm – 10 cm)	
Crack Depths	3" – 12" (8 cm – 30 cm)	1 – 3 cartridges/shallow cracks
Cavity information:		
Diameter	3" – 4" (8 cm – 10 cm)	
Depth	6" – 12" (15 cm – 30 cm)	
Ambient temperature:	Average of 59° F / 15° C	
Technician access:	Climb	
Application information:	Special instructions – Due to size of cracks and cavities, manufacturer recommended slow injection of UPR-NF resin deep into apex of crack to create first bead of sealant. Let expand and cure. Run two beads of resin along each side of the 1st bead. Wrap pole to contain sealant. Remove plastic after cure.
