**Covanta Essex Company**

Subject: Condition (d) of Phase I, Section B of Administrative Consent Order EA ID# 200001-07736

**COVANTA ESSEX COMPANY Response to  
Condition (d) of Phase I of Section B Compliance Schedule**

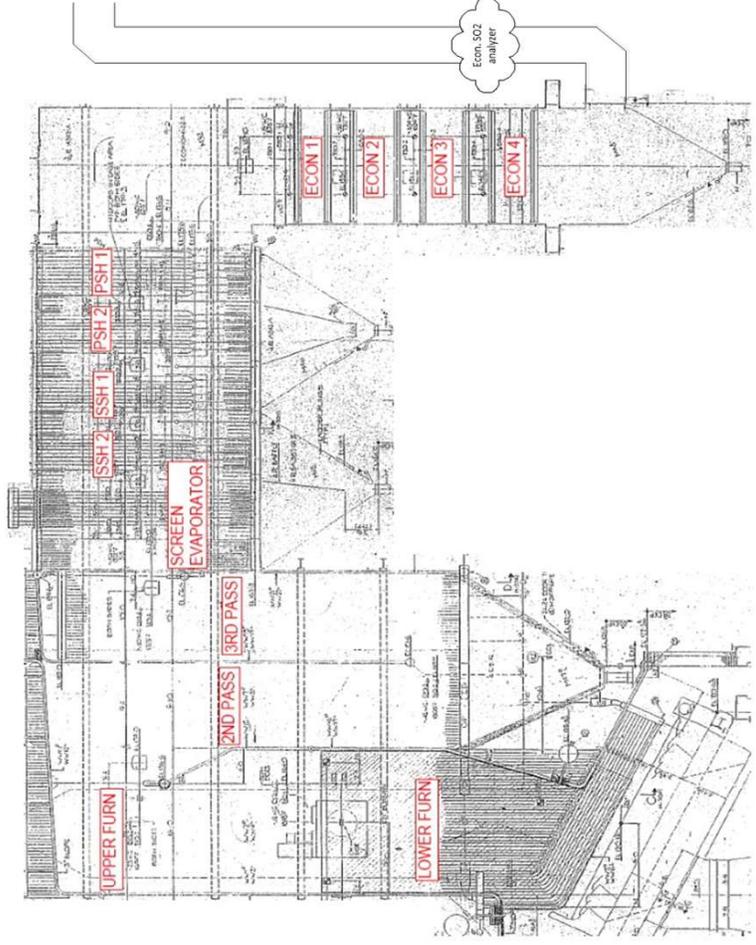
## Covanta Lancaster

- Martin Gmbh grate/furnace/boiler
- Three units, each rated at nominal 400 TPD

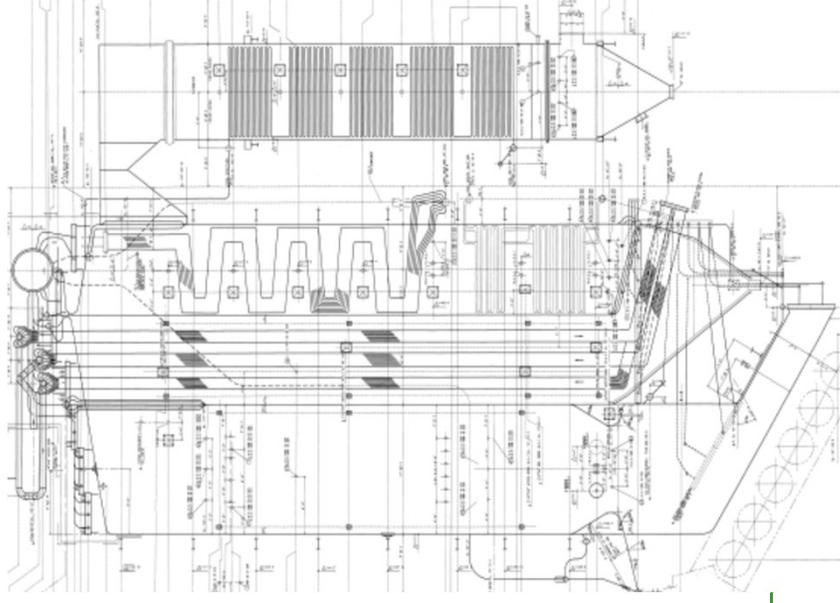
## Covanta Essex

- DBA roller grate/furnace/boiler
- Three units, each rated at nominal 933 TPD

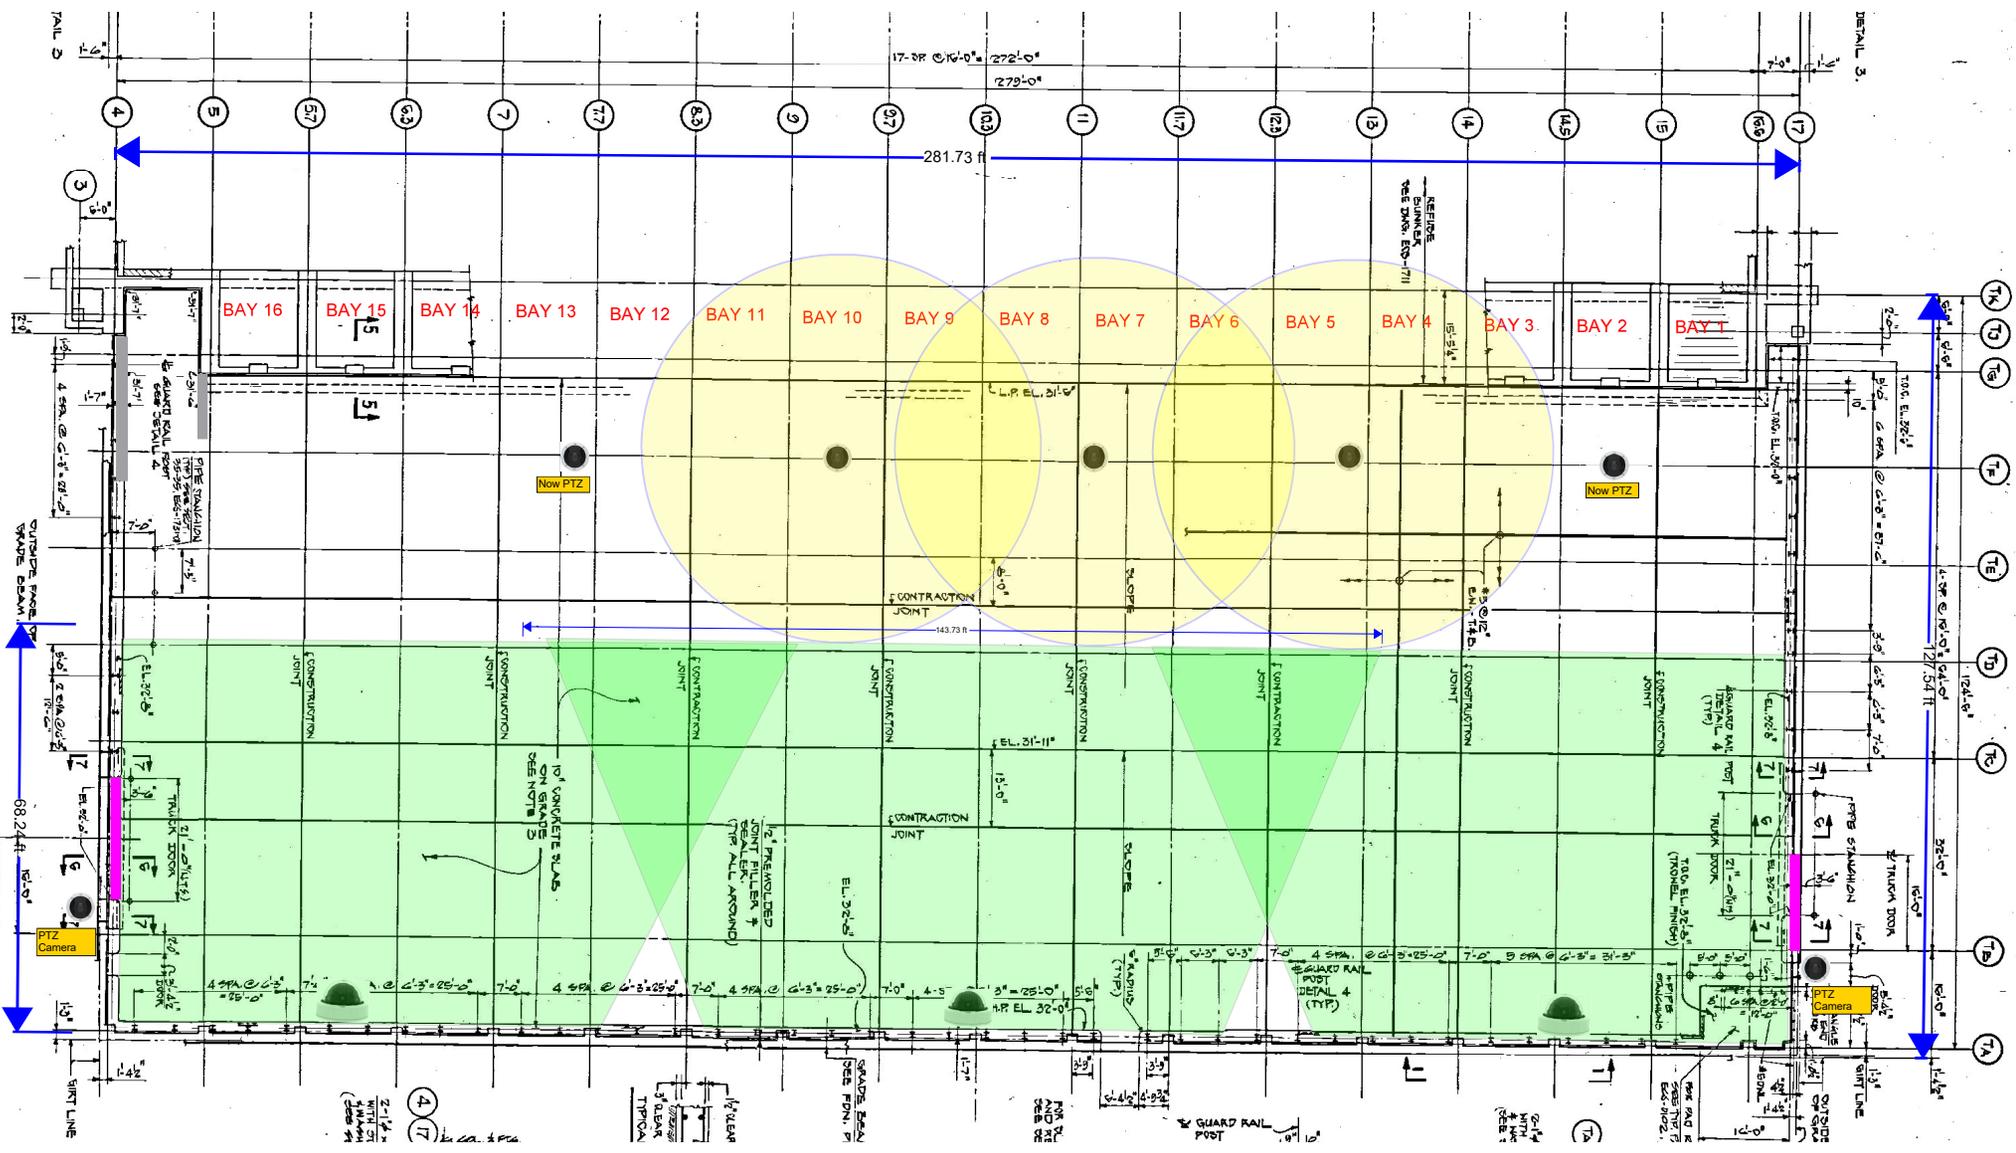
**GROUND FLOOR PLAN AT EL. 32'-0"**

**High Definition (HD) Cameras:** In 2018, Covanta Essex installed 10 HD digital cameras on the tipping floor. These originally included 2 cameras with additional pan, tilt and zoom (PTZ) capability. In 2019, after the increase in purple plume events, two of 10 HD digital cameras in the overhead location in front of Bays 2 and 13 were replaced with the PTZ cameras for a total of 4 of 10 cameras. This PTZ capability allows for greater visual observation of loads. All recorded video footage by the cameras is stored and available for review for 40 days. (Attachment 5)

Covanta Essex plans to also install 7 additional HD digital cameras on the East Wall of the tipping floor, 4 additional HD digital cameras on the North side of the refuse pit, 3 additional HD digital cameras on the South side of the refuse pit, and 3 new HD digital cameras over each of the three boiler feed chute hoppers, which will replace the current analog cameras over the hoppers, as part of the planned fire system upgrade to be installed early this year. (Attachment 5)
