## Taking Utility Pole Safety to New Heights.

Wooden Utility Pole Repair for Lineman Rodeo Event Made Possible with Polywater® UPR™

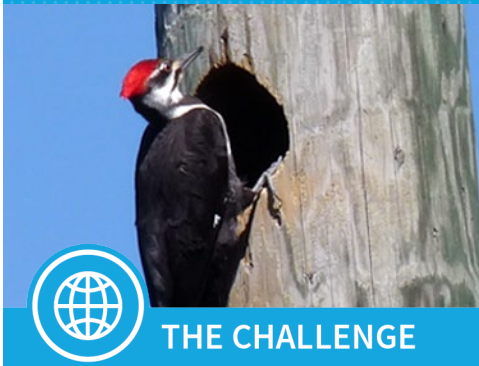
Line workers from around the state compete in hurt-man rescues, equipment repair, and pole-climb competitions during the annual rodeo of a large investor-owned utility company. They are judged on speed, agility, technique, and safety procedures. A week prior to the 2020 Lineman's Rodeo in Florida, the pole yard was constructed. Two days after setting the poles, the staff identified two poles which already had woodpecker damage. The first pole had a 1-inch deep hole and the other was significantly hollowed out.

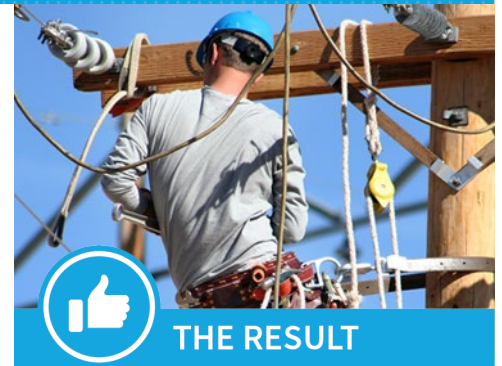
A closer look at the cross sections of the removed pole.

The pole with the smaller hole, was repaired with UPR and remained up for the rodeo event. The repaired pole was inspected and determined to be gaff-able and load bearing—both qualities needed for the upcoming competition. Cross sections of the hollowed-out (removed) pole were examined. It was determined that the UPR had bonded to the wood which prevents moisture from seeping in and further degrading the pole. It was also evident that UPR had fully sealed the hole—from the bottom to the top—due to its 3x expansion. It was concluded that Polywater UPR is a safe and effective solution for repairing damage to wooden poles.
