New Pressurized Flow Component Vastly Improves Fuel Pump Application

Additive Manufacturing Case Study

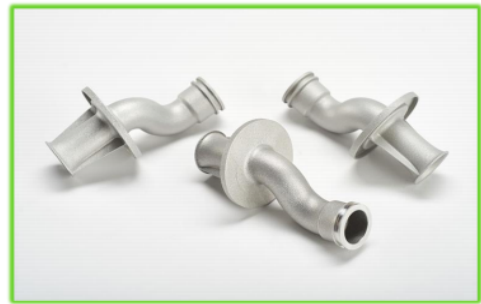
This performance-critical, tube-shaped flow component included a disc that was produced separately and welded to the pipe. Unfortunately, the fuel flowing through the tube cavity was corroding the weld, leading to **higher than expected maintenance and repair requirements and raising the risk of failure.**

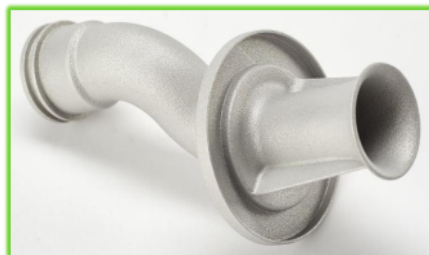
The Metalcraft team immediately focused on developing a **one-piece, 3D printed solution**. It experimented with various materials and build orientations, and despite several engineering changes that altered the dimensions of the part, the material thickness and the final machining requirements, Metalcraft Solutions quickly developed a manufacturing solution after just a few iterations.

In the end, the customer received a far superior product that was less susceptible to corrosion and wouldn’t cause downtime for unexpected repairs.
