UPR-NF Provides Performance at the Extreme

Polywater® UPR™ Saves Customer Time and Money with Remote Pole Repairs

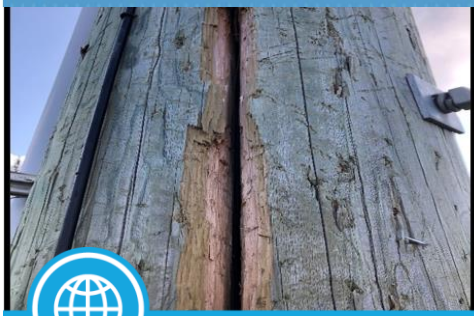
Extreme Cracks Due to Weather and Environment.

A large oil and gas facility in northern Alberta had more than 60 severely cracked wooden utility poles that were further damaged by woodpecker foraging. The poles either needed to be replaced or repaired to limit further damage and loss of mechanical integrity. Due to their remote location, the logistical costs of moving new poles to the site were too high to justify replacement. The maintenance crew decided to repair the existing wooden utility poles. The company needed a product that could fill the voids and halt the damage from pests and moisture. So, they reached out to Polywater to inquire about a product solution that could fill the cracks while preventing further damage to their utility poles.
