AirRepair Leads the Way

AirRepair[®] Leak Repair solves a cracking problem

Cracked Lead-Sheathed Cable in Manhole

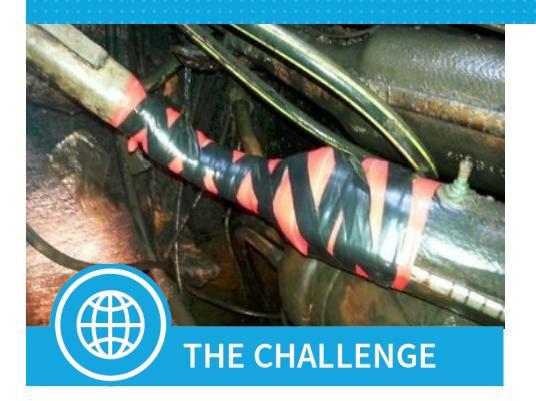
Chris Godfry, employee of a British telecommunications company, was experiencing problems where lead sheathed paper-insulated E/side cables were cracked within the duct mouth. This caused high airflow and created an opportunity for water ingress.

It was believed the cables were inadvertently damaged through increased manual activity in underground networks when installing fiber. Footprints were observed on the cables. When these cables fail, the average cost of replacement is £5,000 (US \$5.917).

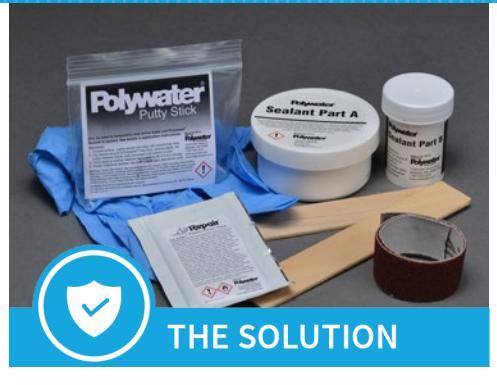
Previous attempts to repair the hole were made with tape and putty. Unfortunately, the tape did not provide stability when the cable was moved, allowing the cracks to continue to propagate, and the compression tape leaked.

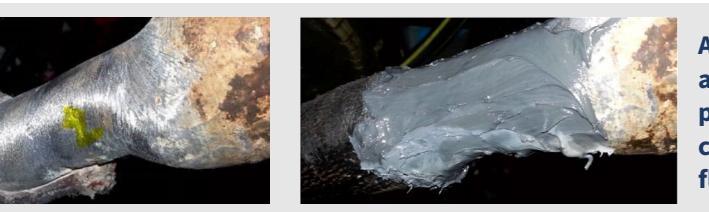
A closer look at the repair process to create a flexible seal.

Godfry felt AirRepair Sealant could be an excellent solution for in-field repair. It is supplied in single, user- friendly, ready-to-use packs, and can be applied to pressurized cable so there is no service disruption. The no-sag material requires no special application tools.

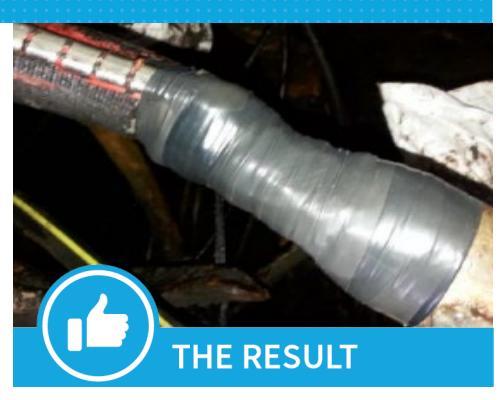
Within 10-15 minutes, the AirRepair seal stopped the air leaks and limited further cracking. This repair has better results and performance than tape and putty used in the past. The highstrength AirRepair seal lends stability to the cable so it can withstand vibration and movement—even footsteps.

AirRepair cures to a durable material that flexes and moves with the cable. The seal holds 10 psi (690mb) and is resistant to water, salt, oils, and other manhole contaminants.
