Eliminate the Most Common Splicing Errors with the **Next Generation Splicing Solution**

*Tsukasa Ueda, GBD
Keith Iwai, LNPD*

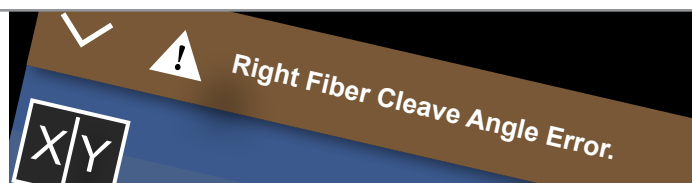
Figure 2. Caution message for poor cleaves (example)

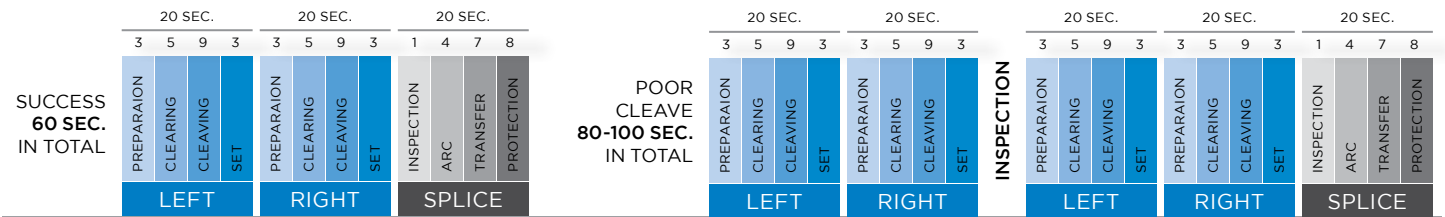
Figure 3. Time chart comparison between (a) a successful splice vs (b) rework due to poor cleaves (The time was measured using a single fiber core alignment splicer. Time for each process may vary depending on the skill of operators.)

The following chart shows the timeline of a typical splice. If the fiber is cleaved properly and the splice is successful, 1 splice takes approximately 60 seconds. However, when a “rework” is required by the splicer, the cycle resets, and it takes approximately 80-100 seconds. This lost time accumulates quickly and reduces work efficiency in the field.

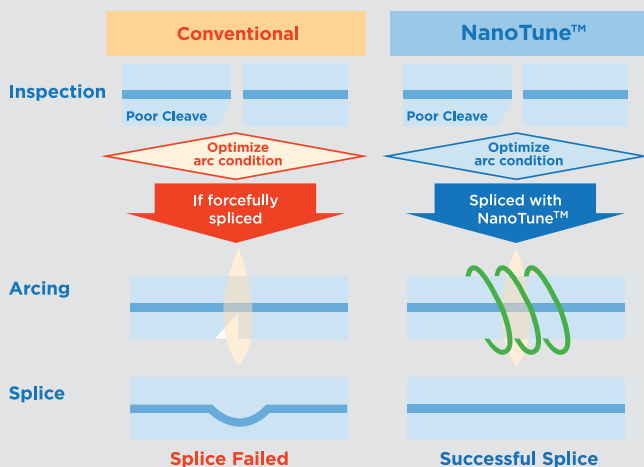
Figure 7. Process comparison between conventional splicers and a splicer with NanoTune™. Test results at right (Figure 8) show this insertion loss. Traditional splicers alert and request rework when a bad cleave is detected to maintain good splice performance. If the alert is ignored, bad cleaves often result in bad insertion loss (yellow). NanoTune™ has improved splicing capabilities of poor cleaves, enabling splicing of such fibers with low loss (blue) utilizing this state-of-art AI technology.

NanoTune™ technology's main aim is to support the operators in the field. NanoTune™ reduces your time spent working and reduces splicing loss overall, by using the world's first AI splicing technology. Reworks, especially during fiber preparation, occasionally occur, even for the most skilled operators. NanoTune™ drastically reduces the need for these reworks, by enabling the operator to splice fibers that would have previously required rework. NanoTune™ realizes this by using state-of-the-art technology and our unique algorithms to accurately adjust parameters when splicing. NanoTune™ improves your field splice success rate to 90%, thus shortening your working time drastically.
