FST Stops a Gnawing Problem

Risers Sealed with Polywater FST to Stop Squirrels from Damaging Cables.

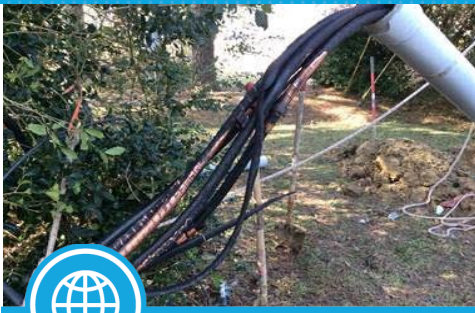
Squirrels Damage Cables in Riser

The open top of riser poles and u-guards are vulnerable to both weather and rodents. Customers of an electrical cooperative in North Carolina were becoming frustrated and angry due to service interruptions. When lineman crews were dispatched, they found cables stripped of their protective jackets and insulation. The cause was found to be a squirrel. As the problem persisted, it was obvious the squirrel hadn't been acting alone and the solution was to seal the top of the riser pole to keep the pests out. But sealing larger cables in risers can be difficult due to multiple cables, often in complex configurations such as tri-plexed.

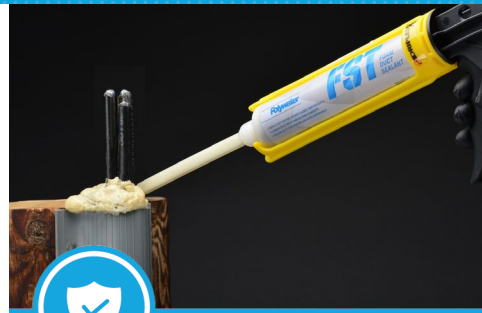
Creating a Barrier to Rodent Entry with FST

The cooperative evaluated riser sealing products. Mechanical riser covers needed to be specific to the inner diameter of the riser/u-guard, to the number of cables in the configuration, and to the outside diameter of the cables. Additionally, the cooperative feared the plastic seals could be gnawed by rodents. The challenge with traditional duct seal or single-part insulating foam is they fail very quickly.

Polywater FST was selected because it was specifically developed as a conduit sealant to be compatible with all cable jackets and conduit types. The closed-cell foam cures to a strong rigid barrier but is removable when future access is required. It can seal any configuration of cables in any size ID of risers or u-guards.

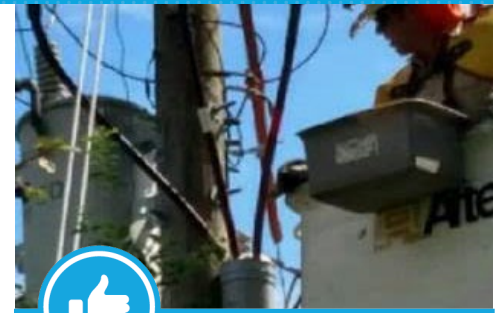
Effective and Cost-Efficient Solution for Squirrels

Polywater [FST](#) was installed in the top 3 inches of the riser pole with the cables in place. This airtight/watertight seal created a tough, UV stable barrier to weather and rodents. Polywater FST is compatible with all cable/conduit sizes and materials so the system remained intact. The cooperative was very pleased with the results and the customers were much happier with the reduced outages.

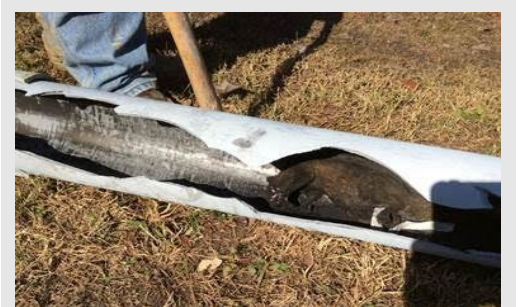
A closer look at the cause of damaged cables and outage.
